SEA TRANSPORT

Cartagena Port (Spain)

06-09.06.2018

EXTERNAL REPORT

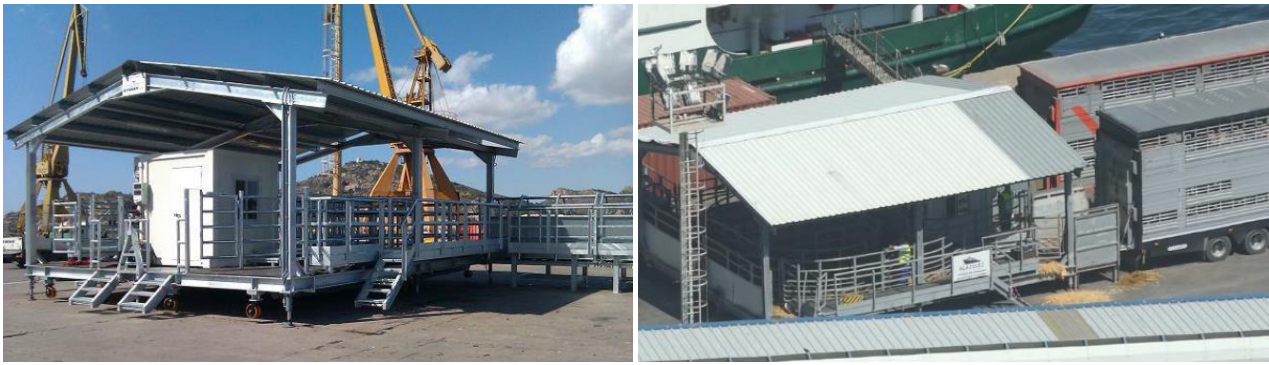
Figure 1. Facilities to unload the animals from road vehicles onto vessels. Cartagena Port, 07/06/18.

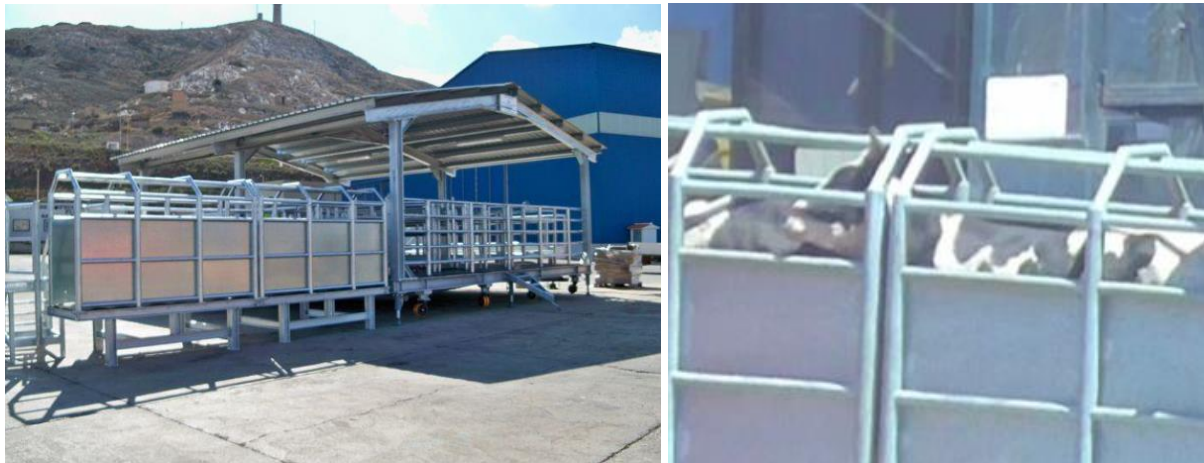
Figure 2. Movable gangways between the solid corridors and the movable ramps from the vessel. Due to their construction, the movable gangways pose a risk of injuries, especially for the animals with long horns. We observed several animals with horns stuck between the metal bars. Cartagena Port, 08/06/18.

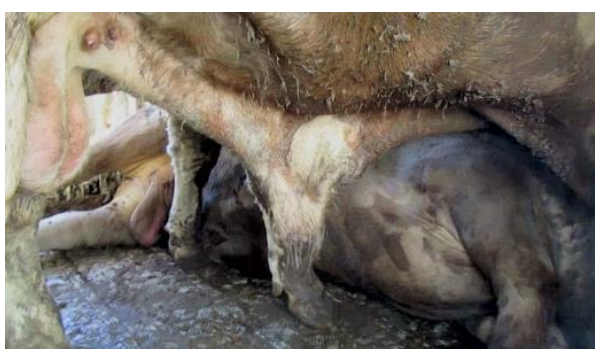
Figure 4. Bull collapsing, probably just before he dies, trampled by the others without possibility to protect itself. 06/06/18.

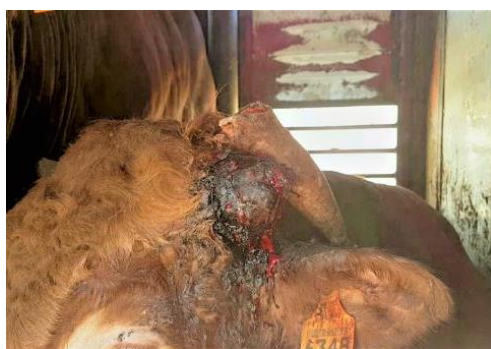
Figure 6. Portuguese bull with a significant horn injury before the journey by sea. Cartagena, 08/06/18.

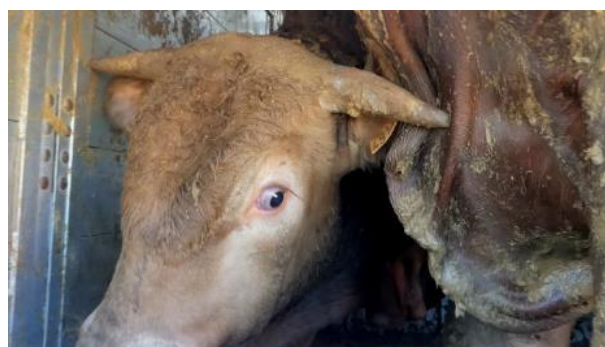
Figure 7. All French bulls from this road vehicle are all covered with their own faeces. Cartagena, 08/06/18.

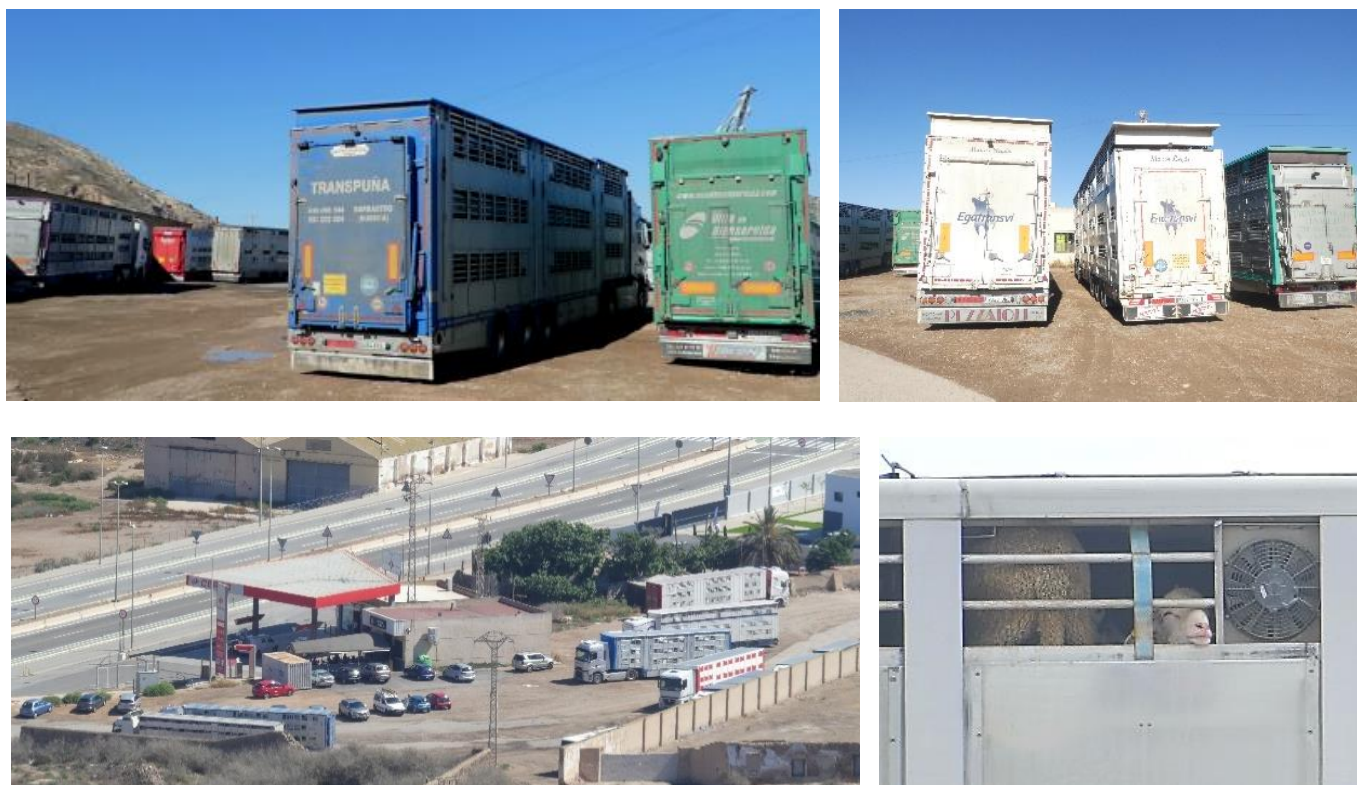
During our visit, the minimum waiting time at the parking lot outside the Port was 1 hour, but many vehicles spent over 4 hours there with the animals onboard. Sometimes we observed more than 10 vehicles parked at the same time at this unofficial waiting zone, without any facilities for animals at all. The animals waited for hours in the sun, without shadow and without water or mechanical ventilation system turned on. During this long waiting time the drivers were waiting inside the bar without checking the welfare of their animals.

Figure 8. Several vehicles loaded with animals, waiting for hours in the sun without water, with mechanical ventilation system turned off. Cartagena, 06/06/18 and 07/06/18.

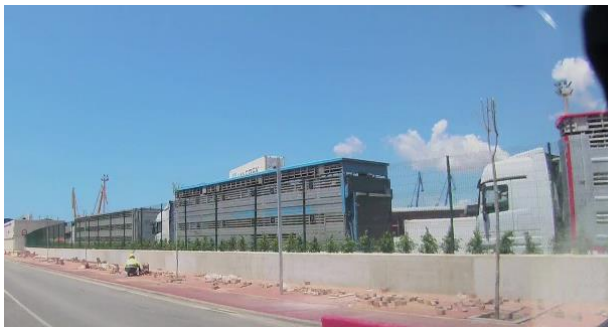
During our visit, after hours of waiting outside the Port (in front the Bar-Restaurant El Gato 2), the road vehicles went inside the Port to wait for their turn to load the animals on to the Vessel. At this last waiting stage in Cartagena, the vehicles first were weighed in the scale zone, and parked again with animals on board, because the infrastructure inside the port to unload animals is not used. The Port does not provide any shadow, and we cannot confirm that most of the animals received water or mechanical ventilation until they were inside the vessel. At times, there were more than fifteen vehicles waiting at the same time to start the unloading of their animals.

Figure 10. Vehicles loaded with animals waiting in the scale zone. Cartagena 07.06.18

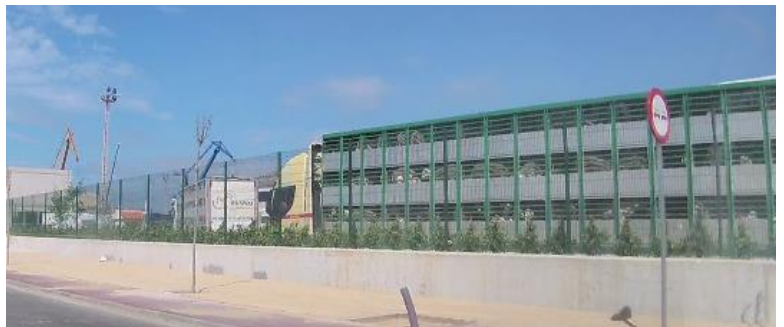
Figure 11. Vehicles loaded with animals waiting in the scale zone. Cartagena 08.06.18

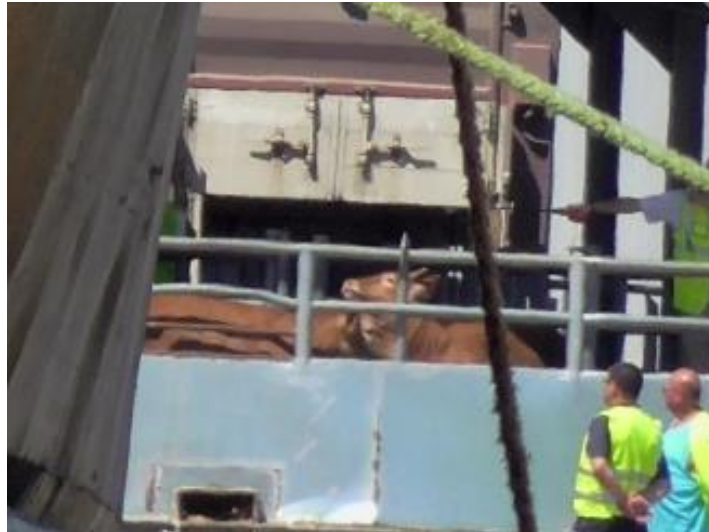
Due to this inappropriate handling of animals by the workers, the loading is becoming very difficult; the same routine is observed repeatedly during the entire day: animals going in opposite directions in the corridors; animals returning from the ramp to trucks; scared animals and animals fighting with each other due to their disorientation and high stress levels.

Figure 27. Animals fighting with each other due to the disorientation and bad management by the workers of the Port.

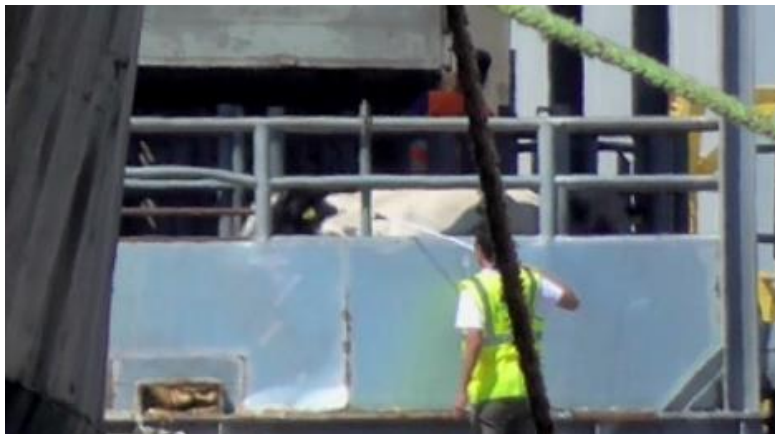
Figure 28. One of the young workers using the electric prods on sensitive areas of the animals, e.g. their face.

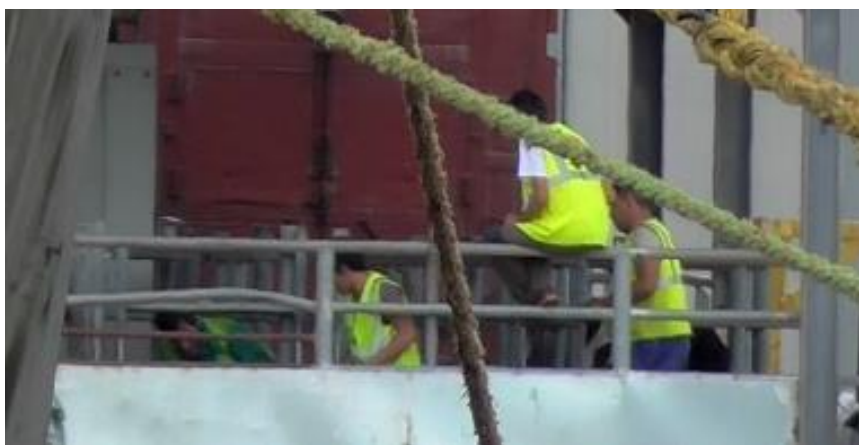
Furthermore, it is important to remark that **during the loading of *Freedom* we documented animals that should never have been approved as an animal fit for a long-distance transport by sea.** We saw a downer bull that could not get up by himself and four workers tried to move him, continuously applying electric shocks on the weak animal, in order to lift him and redirect him to the loading ramp. Instead of loading this bull onto the vessel, it should have undergone humanitarian slaughter in Spain. This fact confirms the insufficient supervision of fitness of animals for long-distance transport by the veterinary authorities in charge.

Figure 29. Downer bull that cannot get up by himself. Four workers are trying to move the animal, they continuously apply electric shock on the weak animal. Loading of the *Freedom*, 06.06.18

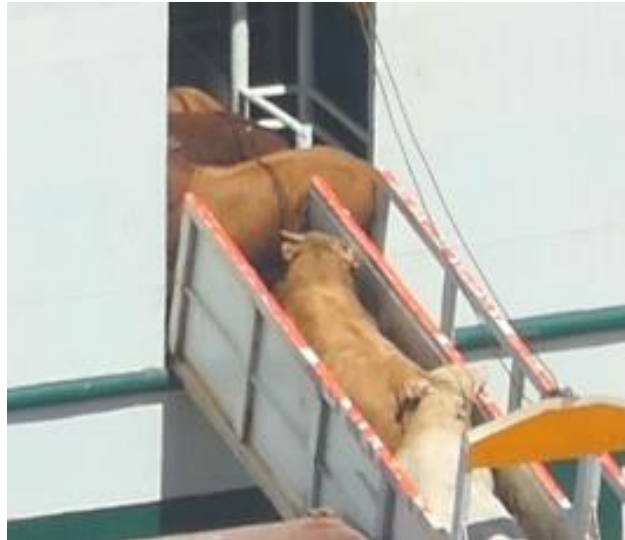
We note that the gangway ramp of the vessel has an adequate angle for easy loading and we see bedding inside the ramp to prevent animals slipping. However, there is a gap between the top part of the ramp and the vessel, and a fully closed lateral protection with a minimum height of the size of adult bovines is missing, which poses a risk of injuries. We also notice that the entrance of the vessel is very dark causing animals to balk in front of it.

Figure 30. Gap between loading ramp and vessel with potential risk of injuries.

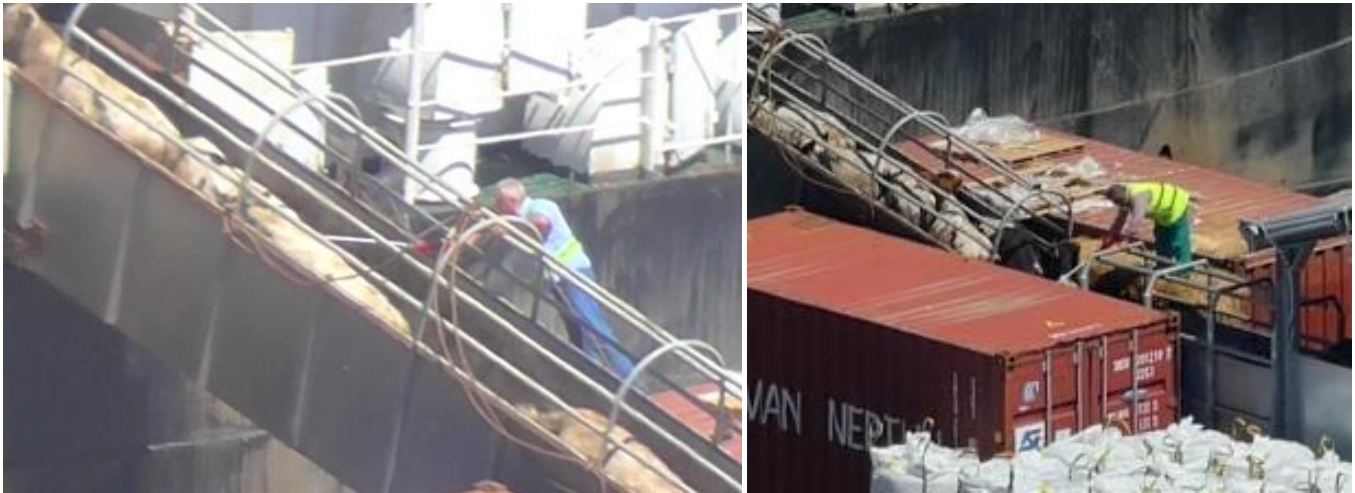
Figure 33. The electric cattle prods used excessively on almost all the animals by Port workers and by crewmembers.

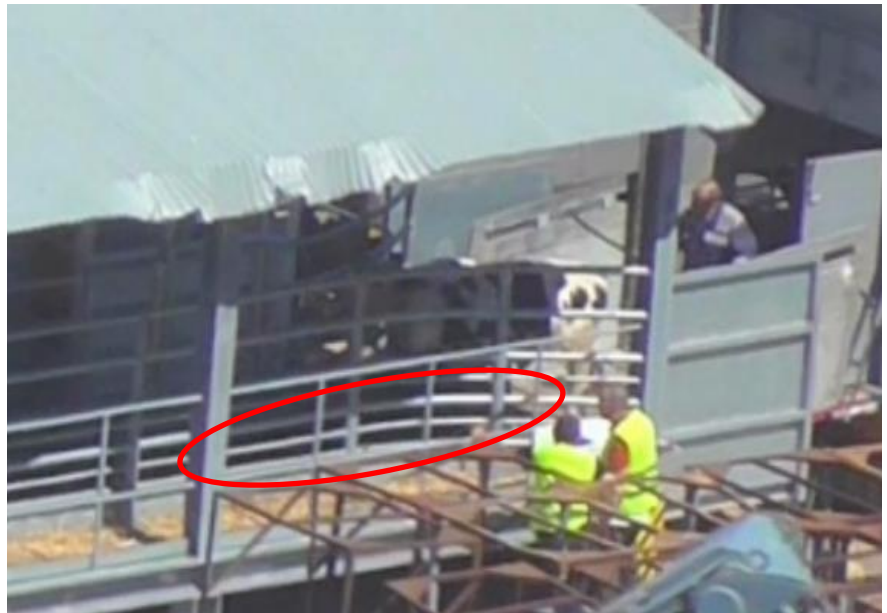
Figure 35. Second downer animal seen by our team loaded on the *Spiridon II*, falling down after unloading from the road vehicle. The driver tries to get the animal making up in such a way that the other animals trampled the defenseless bull.

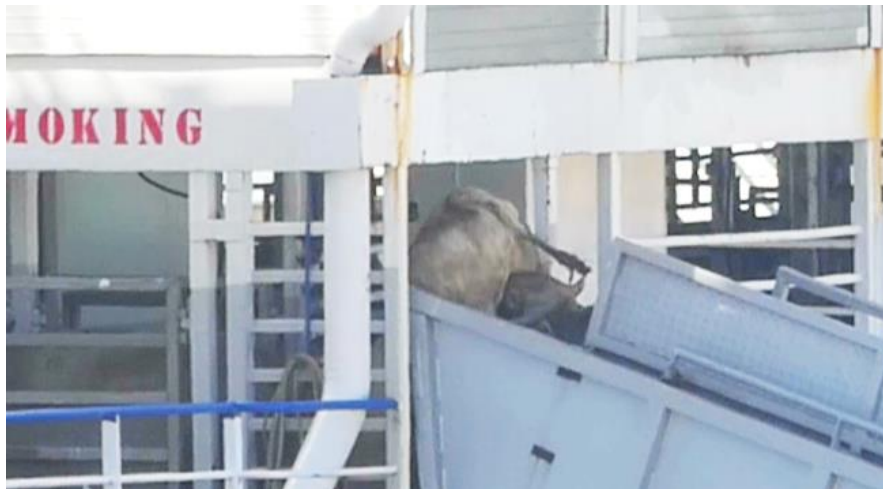
Figure 36. When the loading is made with rush and excessive use of electric prods, the stressed and confused animals often fight with each other. Bull pushing another bull from the back, the victim is lifted up to a vertical position as consequence.

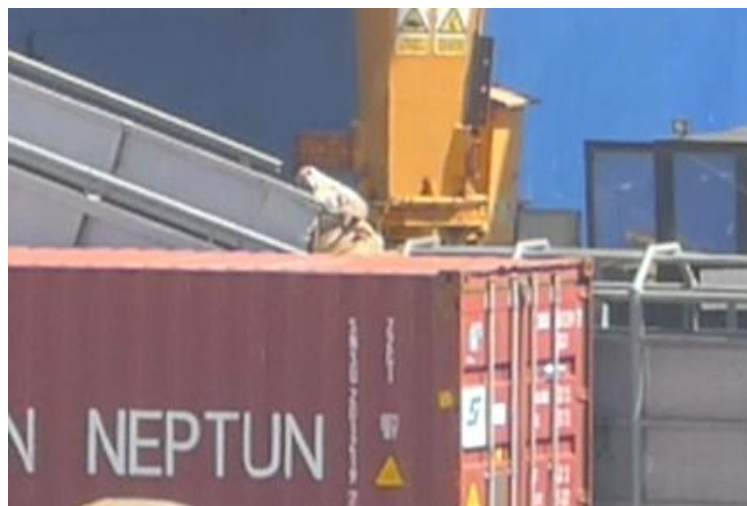
We see that the gangway ramp of the vessel has a very steep angle, which makes easy loading impossible, and consequently, we see some animals slipping. This ramp has solid and fully closed lateral protections (preventing animals from escaping), and its raceway does not have metal construction over it (avoiding possible injuries with the horns), but at the beginning of the ramp there is a big gap that poses risk of injuries.

Figure 37. Dangerous gap at the beginning of the ramp posing risk of injuries. We saw animals' heads getting stuck there during hasty loading.

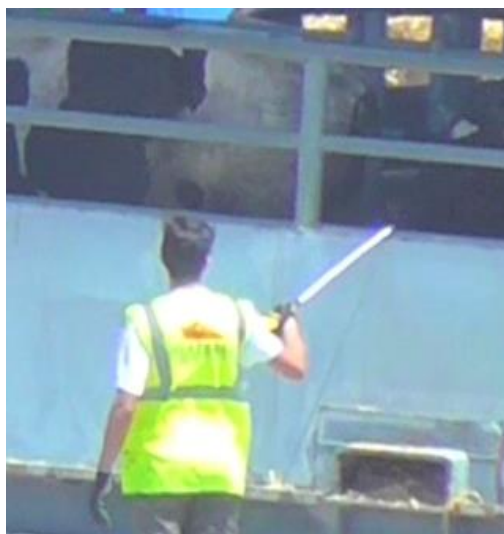
Figure 38. Young worker playing with applying electric shocks on the faces of the animals even when the loading is stopped, and the relaxed animals are waiting in the corridor.
